# Manhole Inspection Summary

Manhole # S67S\_\_012MH

**Location** Address: **1600 Joplin St.**

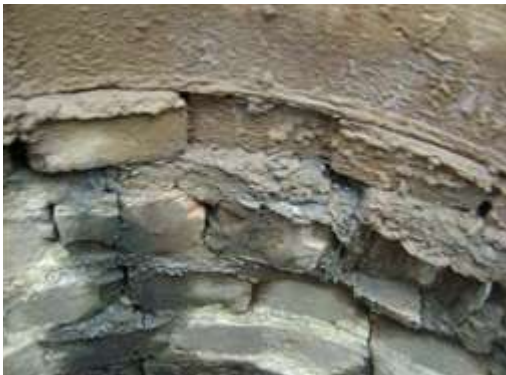
Defect 1

Condition: ☐ Sound ☐ Cracked ☐ Root Intrusion ☒ **Loose Brick** ☒ **Deteriorated**

Infiltration: ☐ None ☒ **Joint** ☐ Cracks ☒ **Mortar** ☐ Roots ☐ Wall

Deteriorating chimney - loose mortar and bricks.

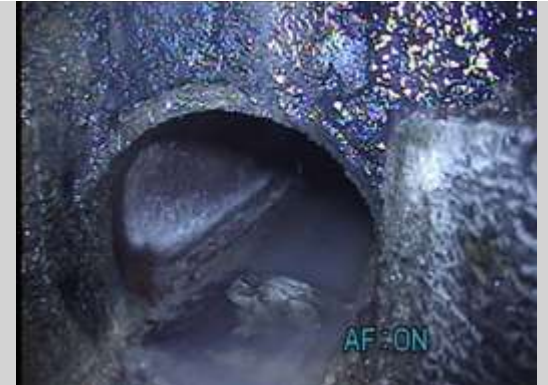
12 O'Clock Outflow

8 in. Circular Gravity Sewer  
Pipe Out @ 12 O'Clock

Pipe Height: **8.4** (in.) Rod and Bar (Angled)  
Pipe Material: **Clay** ☐ Pipe Lined  
Invert Depth: **10.50** (ft.) Flow Characteristics: **Slow**  
Deposits: ☐ None ☐ Mud ☐ Sludge ☒ **Debris** ☐ **Grease**  
Silt Depth: **0.25** (in.) Deposits Extent: **Light**  
Infiltration: **None** Pipe Seal Cond: **Sound**

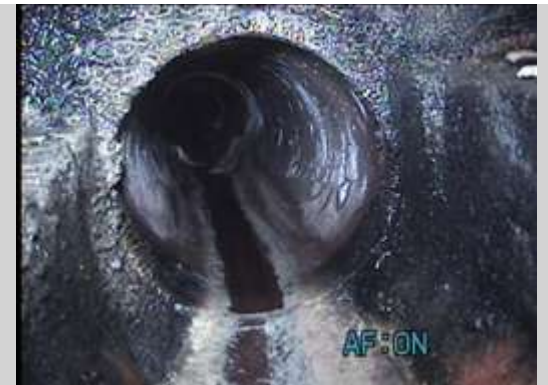
4 O'Clock Inflow

8 in. Circular Gravity Sewer  
Pipe In @ 4 O'Clock

Pipe Height: **8.4** (in.) Rod and Bar (Angled)  
Pipe Material: **Clay** ☐ Pipe Lined  
Invert Depth: **10.13** (ft.) Flow Characteristics: **Slow**  
Deposits: ☐ None ☐ Mud ☐ Sludge ☐ Debris ☒ **Grease**  
Silt Depth: **0.125** (in.) Deposits Extent: **Light**  
Infiltration: **None** Pipe Seal Cond: **Sound**
